IEC 61215-2							
Clause	Requirement + Test					Result - Remark	Verdict
Sample #	M7						—
Ice ball size [mm]..... :	1	2	3	4	5	6	—
	25.0	25.1	24.9	25.0	25.1	24.9	
	7	8	9	10	11		
	24.9	25.0	25.1	25.0	25.0		
Ice ball weight [g]..... :	1	2	3	4	5	6	—
	7.53	7.59	7.47	7.53	7.59	7.47	
	7	8	9	10	11		
	7.47	7.53	7.59	7.53	7.53		
Ice ball velocity [m/s]..... :	1	2	3	4	5	6	—
	23.0	23.1	22.9	22.8	23.0	23.2	
	7	8	9	10	11		
	23.1	23.2	22.9	23.0	23.1		
Number of impact locations	11						—

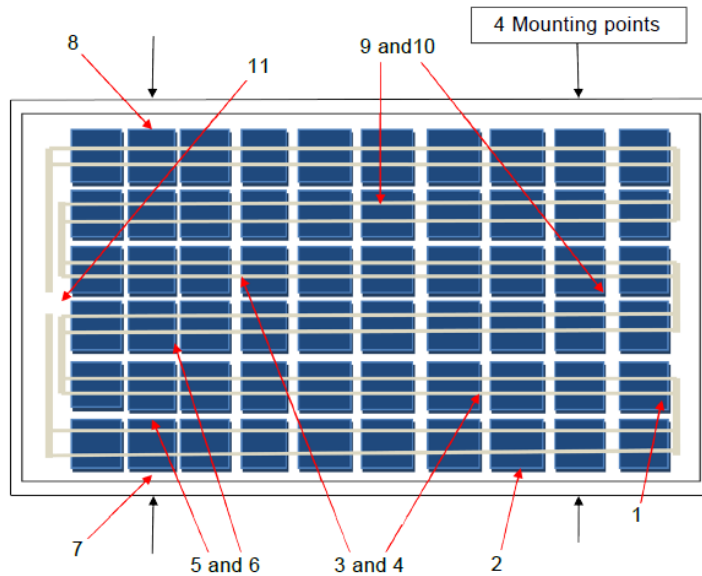
Supplementary information: (impact location descriptions)
